Data collection of failures of main components in GPP

Authors: GEOCAP team WP 2.06
From DNV GL, UGM and ITB

Document number: GEOCAP/2017/REP/DNV GL/WP2.06/xx

Geothermal Capacity Building Program Indonesia - Netherlands

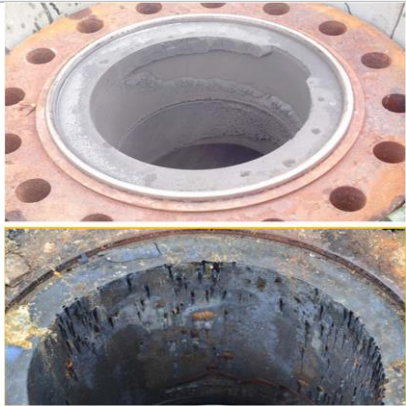
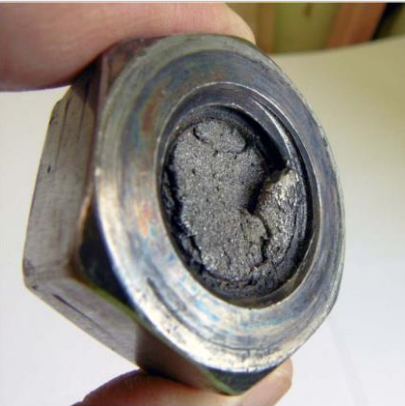
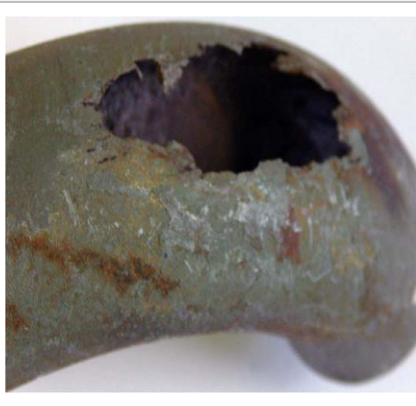
Failure mode	General uniform corrosion	Cracking	Erosion corrosion
Failure location	Wellhead tee	Pipe flange	Pipe elbow
Failure cause	Chemical reaction due to discharge of acid-SO ₄ chloride fluid from geothermal wells	Concentration of Hydrogen molecule formed from H ₂ S carried by geothermal fluid penetrate the components' crystalline structure, reducing its ductility and tensile strength	High speed geothermal fluid that hit pipe elbow. The protective film at that spot are damaged and cause corrosion speed increase at that spot.
Failure effect	Surface thinning with corrosion rate of 2.21 - 2.51 mm/y	-	-
Mitigation			
Short-term mitigation	-	-	-

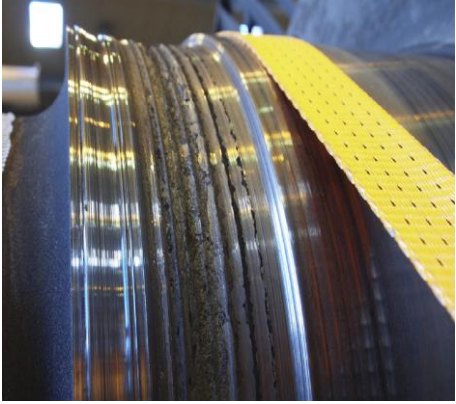
Failure mode	Erosion corrosion
Failure location	Turbine rotor & gland seal (labyrinth packing)
Failure cause	Combination of H ₂ S (11.3%) and CO ₂ (62.57%) that flows in low-pressure side of gland seal system and corrosive gas that condense with steam. Erosion from solid particle and water droplet also contribute.
Failure effect	The labyrinth packing and rotors become too wearied down and corroded for further usage.
Mitigation	
Short-term mitigation	Replacement of damaged components

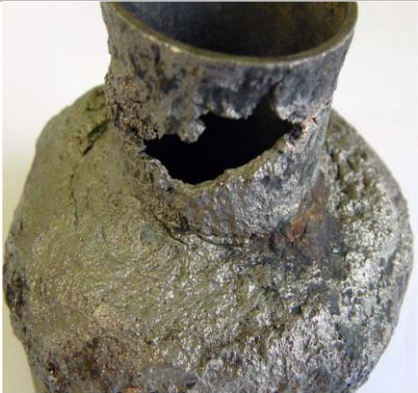
Failure mode	Pitting corrosion
Failure location	Gas ejector nozzle
Failure cause	Accumulation of sulphur deposit inside the nozzle
Failure effect	A hole is formed at the nozzle
Mitigation	
Short-term mitigation	Replace the nozzle with other equipment made with other material (Source does not specify)
