MAINTENANCE OF GEOTHERMAL POWER PLANT MAIN EQUIPMENT

Example of Maintenance in Geothermal Power Plant

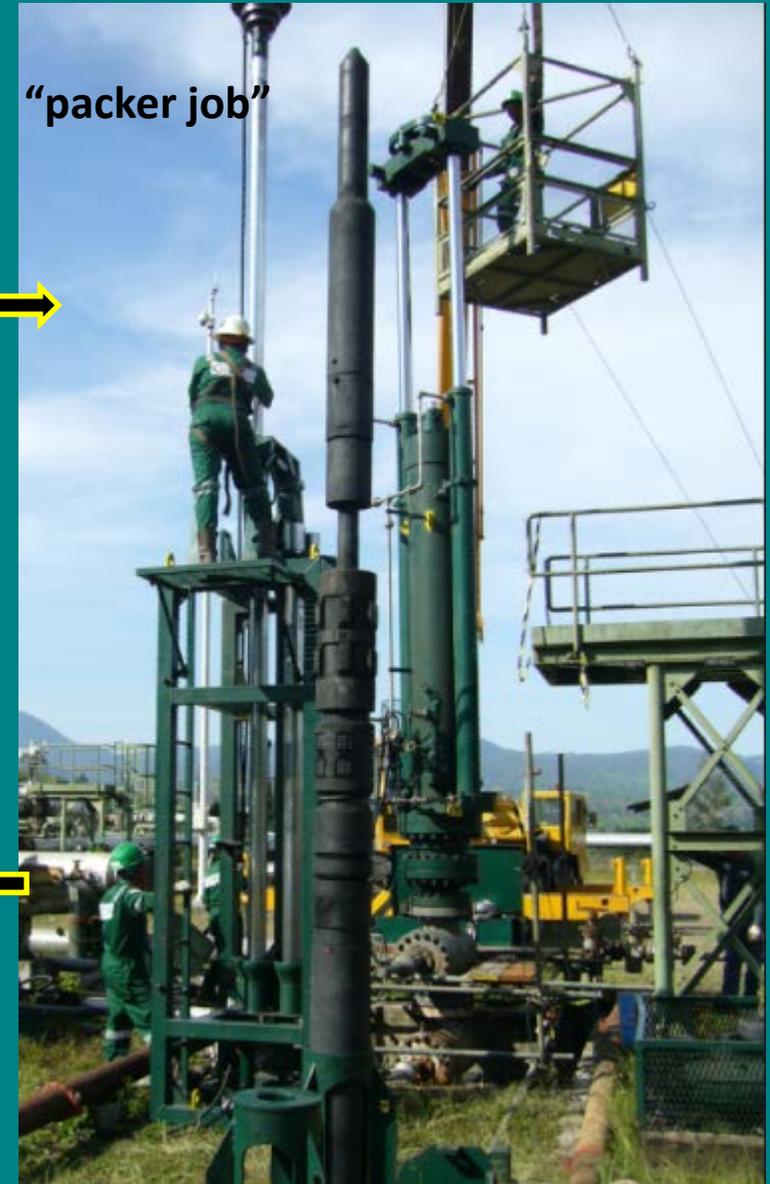
Master valve leakage due to pasing and damage on the RTJ groove, need master valve replacement

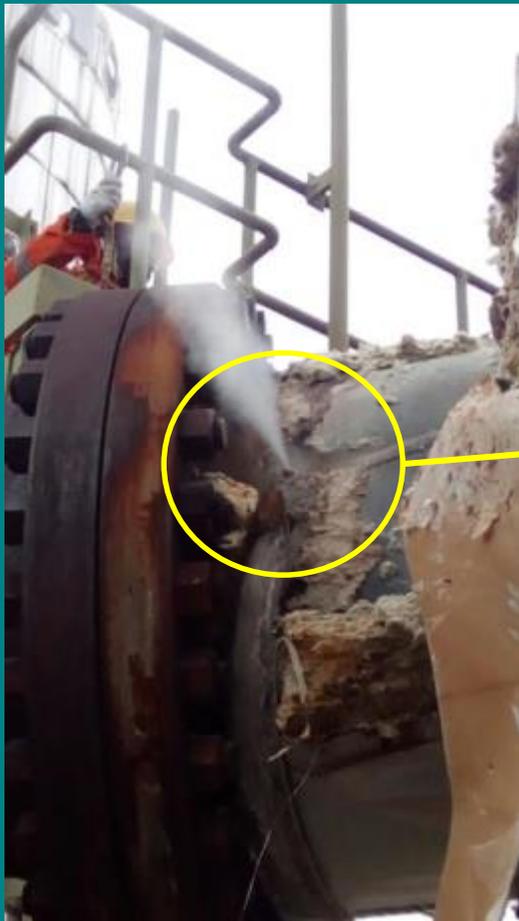
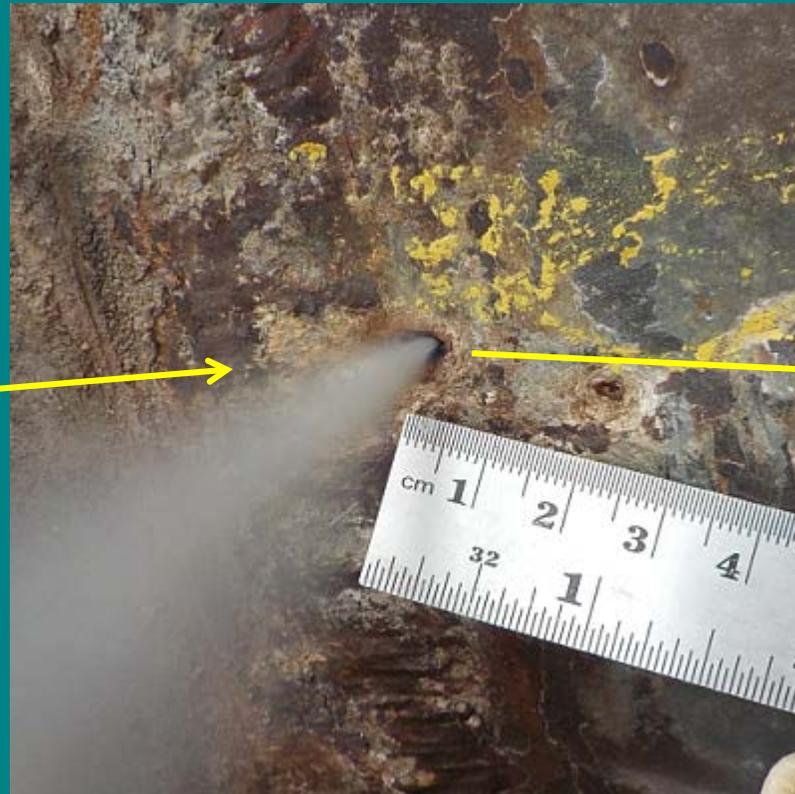
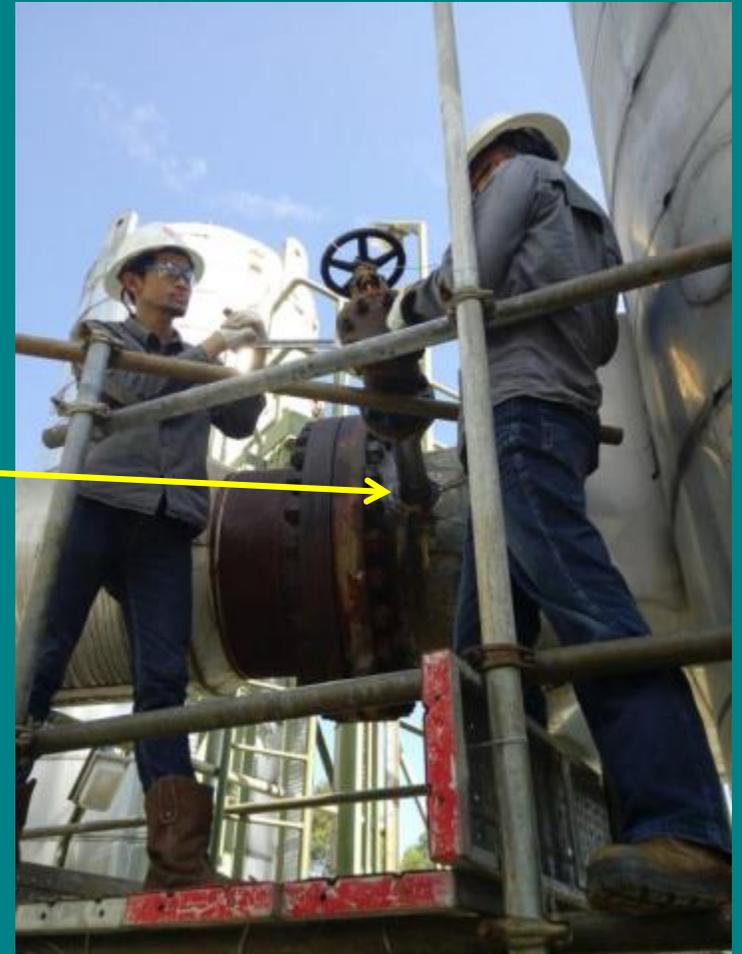
Pipeline and valve leakage

Pinhole leakage in weldment of pipeline

After repair

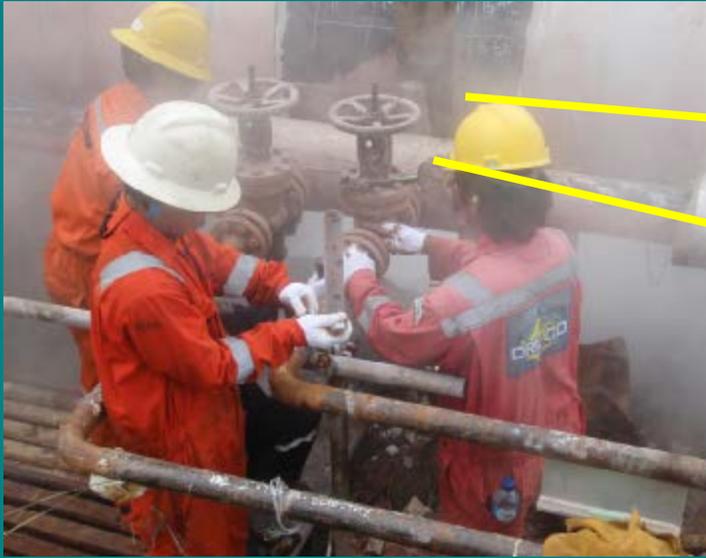
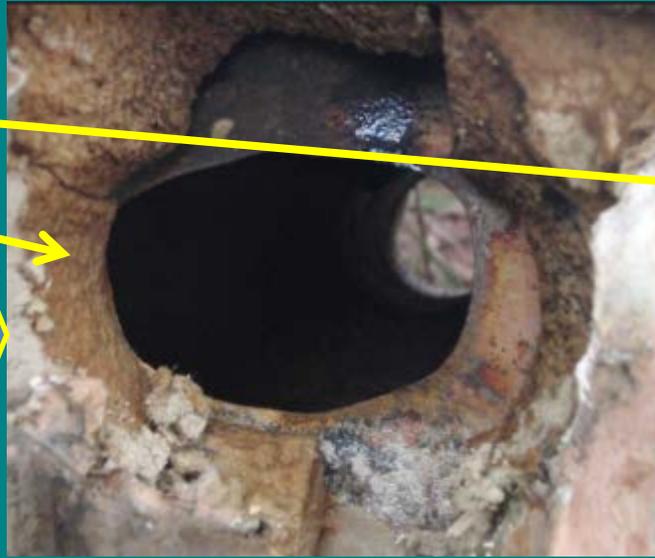
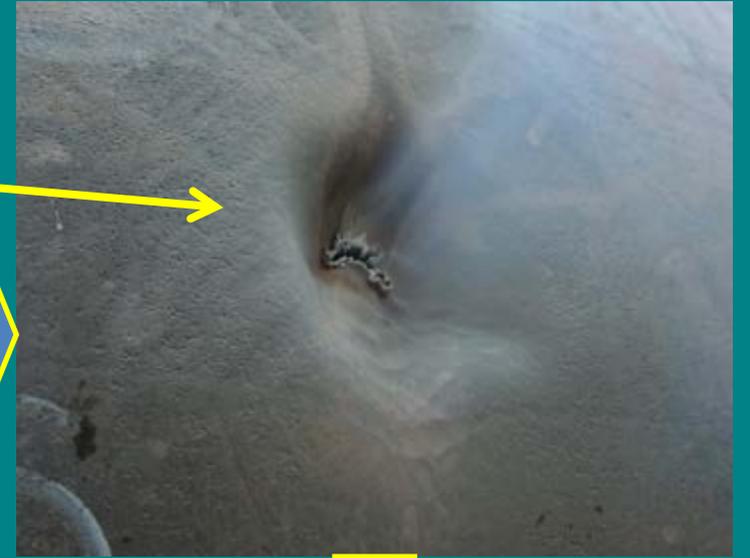
Pipeline Erosion

During well discharge, the particle from well imping the 6" bleeding line and create big hole, and penetrate the insulation of 36" steam header line and until the pipe is ripped a little

Temporary repair by patch welding.

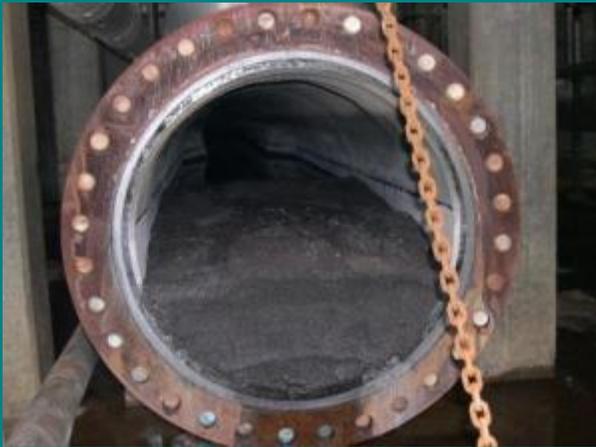
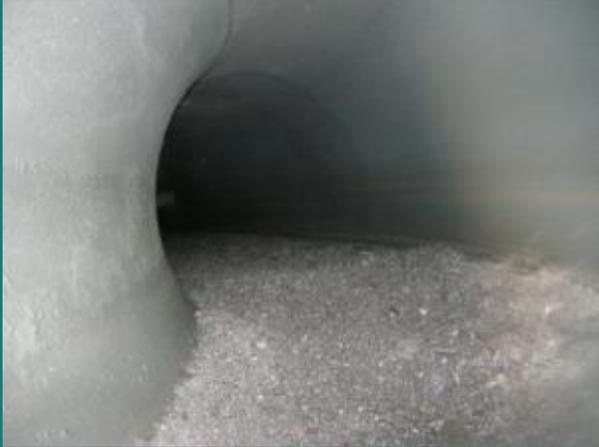
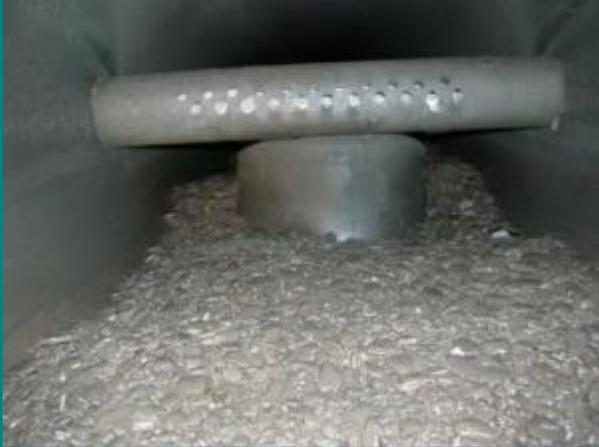
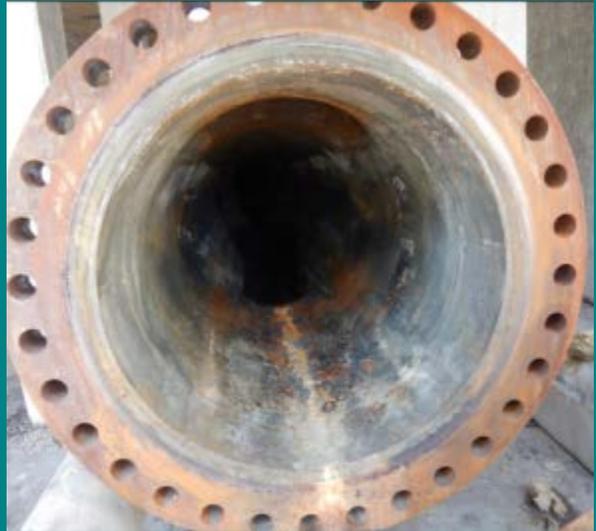
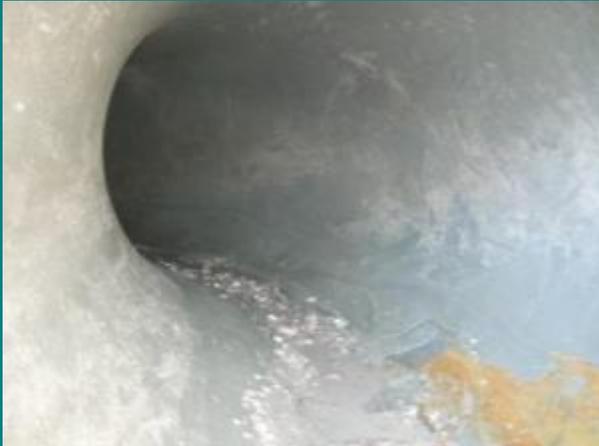
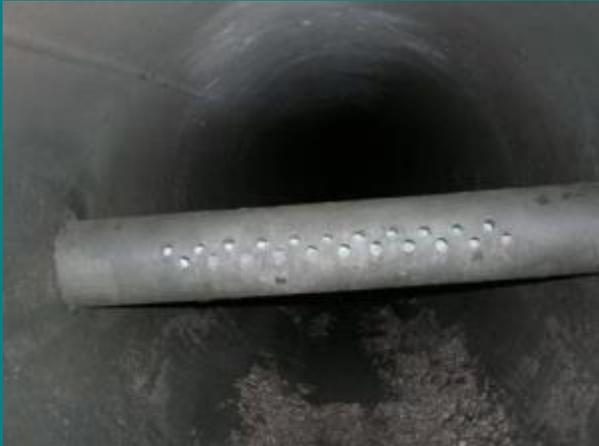
Pipeline and Separator Maintenance

Pipeline before separator cleaning

Dirty trap cleaning

Separator Crack Repair by Welding

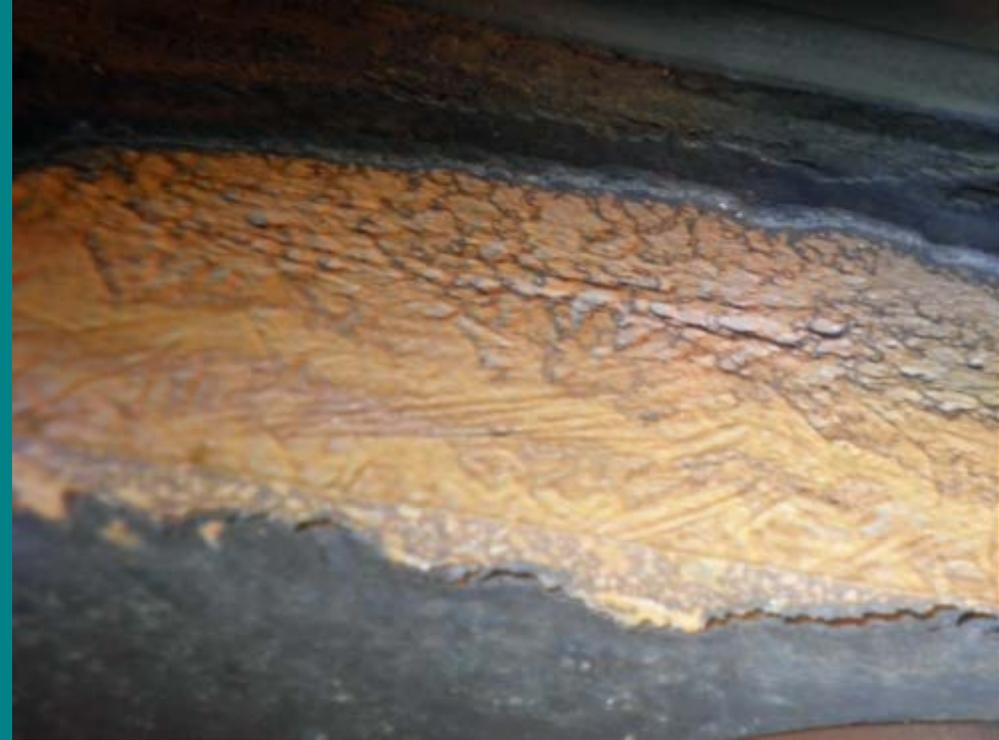
Erosion-corrosion on turbine outer casing

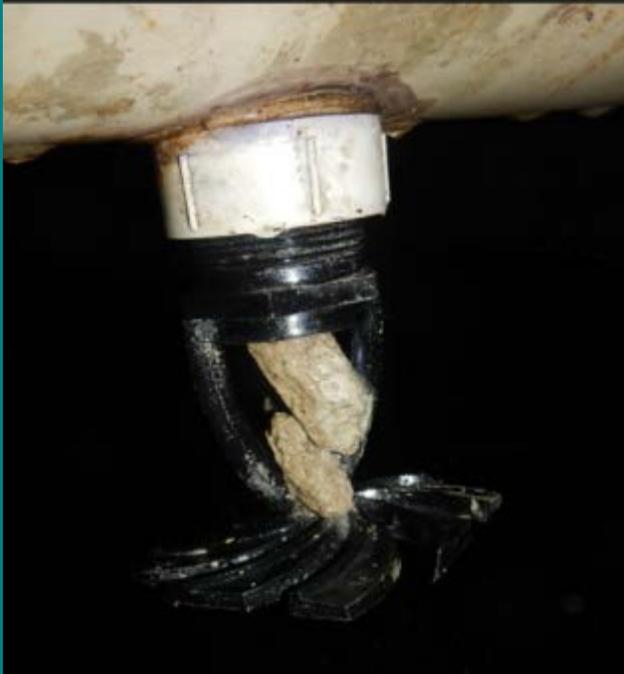
Water distribution nozzle spray clogged by sulfur and silica deposit

Solution :

- *Suitable chemical treatment program (sulfur inhibitor)*
- *Routine cleaning*

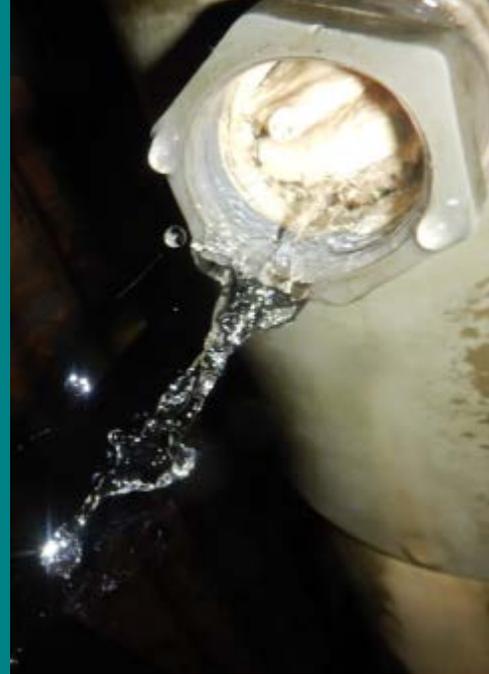
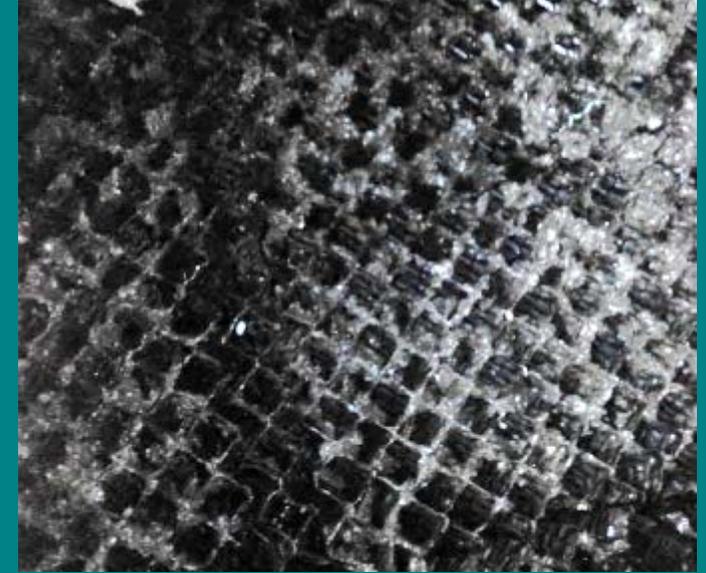
Fill pack clogged by organic deposit

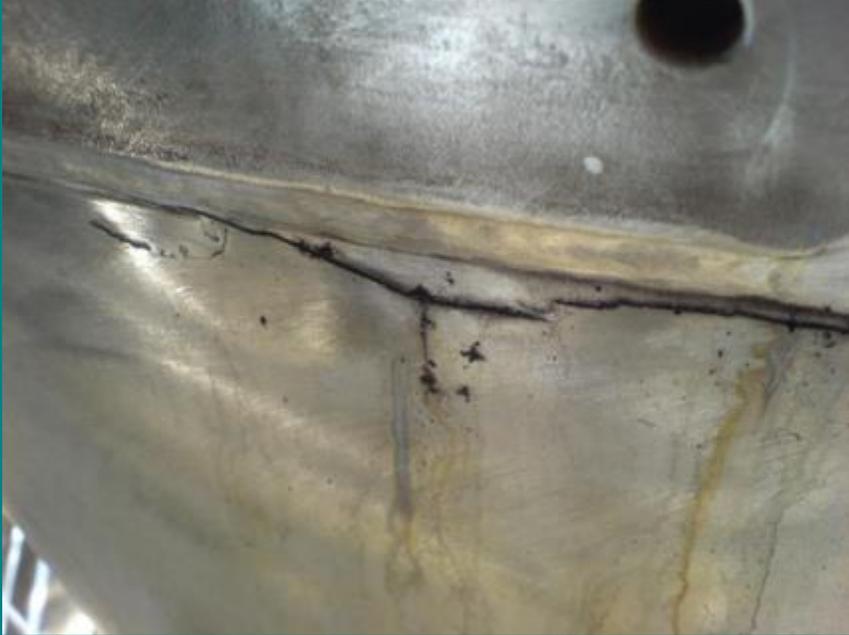
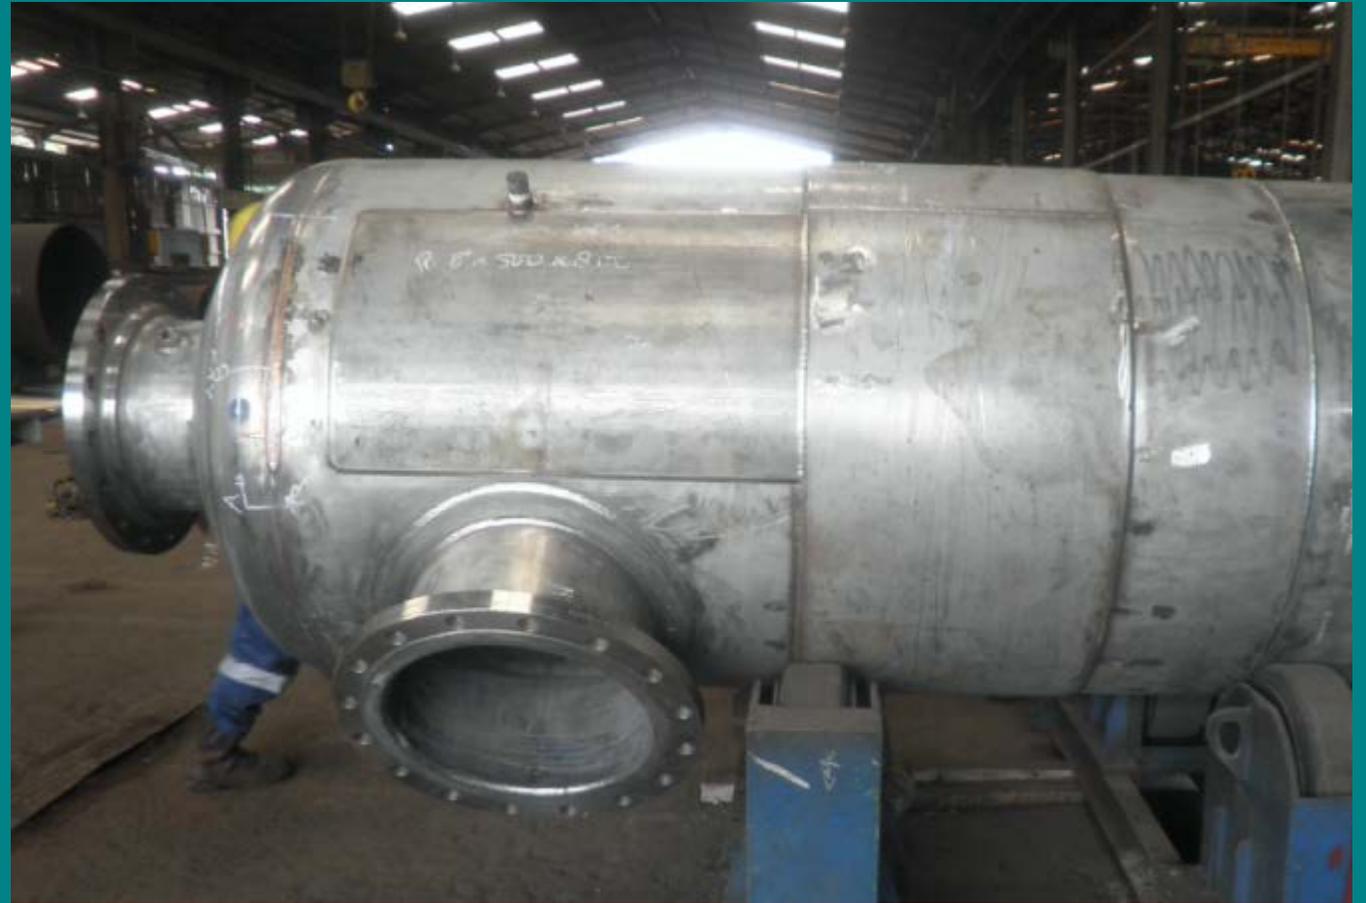
Gas Removal System Maintenance

After condenser vessel 316L crack from sour service, hydrogen induced crack. Repaired by welding and reinforce pad

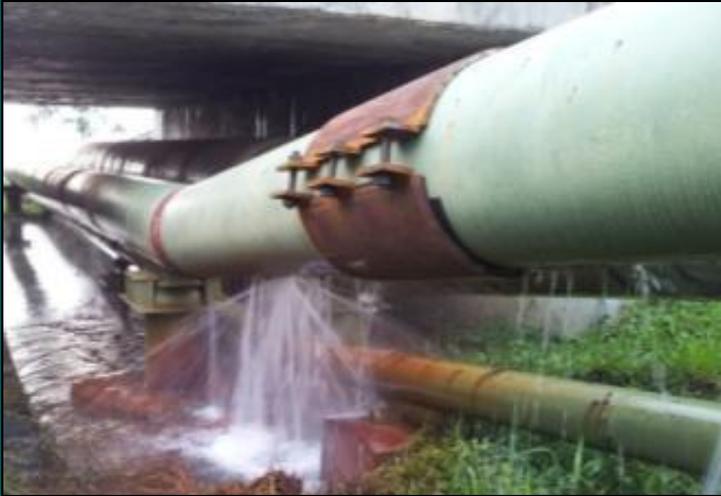
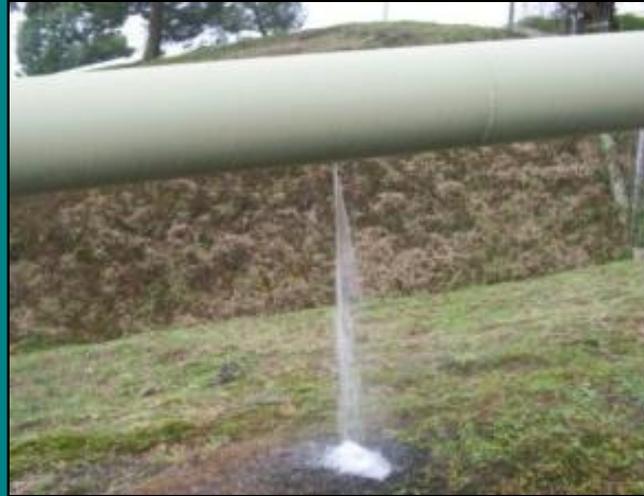
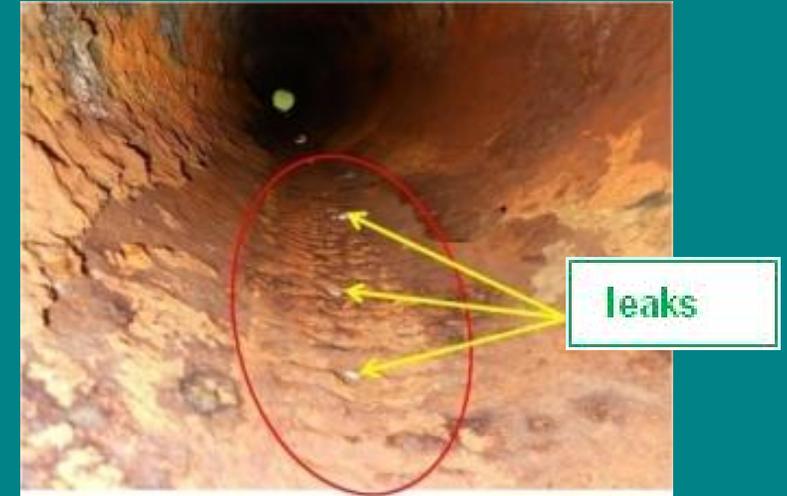
Corrosion on condensate injection system

Condensate line severe corrosion : predicted from dissolved oxygen promoted corrosion. A half of the pipeline already replaced with HDPE pipe. Can not replace all to prevent corrosion on the well casing.

Still consider to sacrifice the rest of pipeline rather than oxygen scavenging or filming amine due to high cost
